Inspection Report

LOCATED AT:
933 Happy Grasshopper Drive
Sugarland, TX 77479

INSPECTED ON:
Friday, September 10, 2021

Inspector, Paul Ferguson, TREC # 6883
A Plus Inspections Of Texas

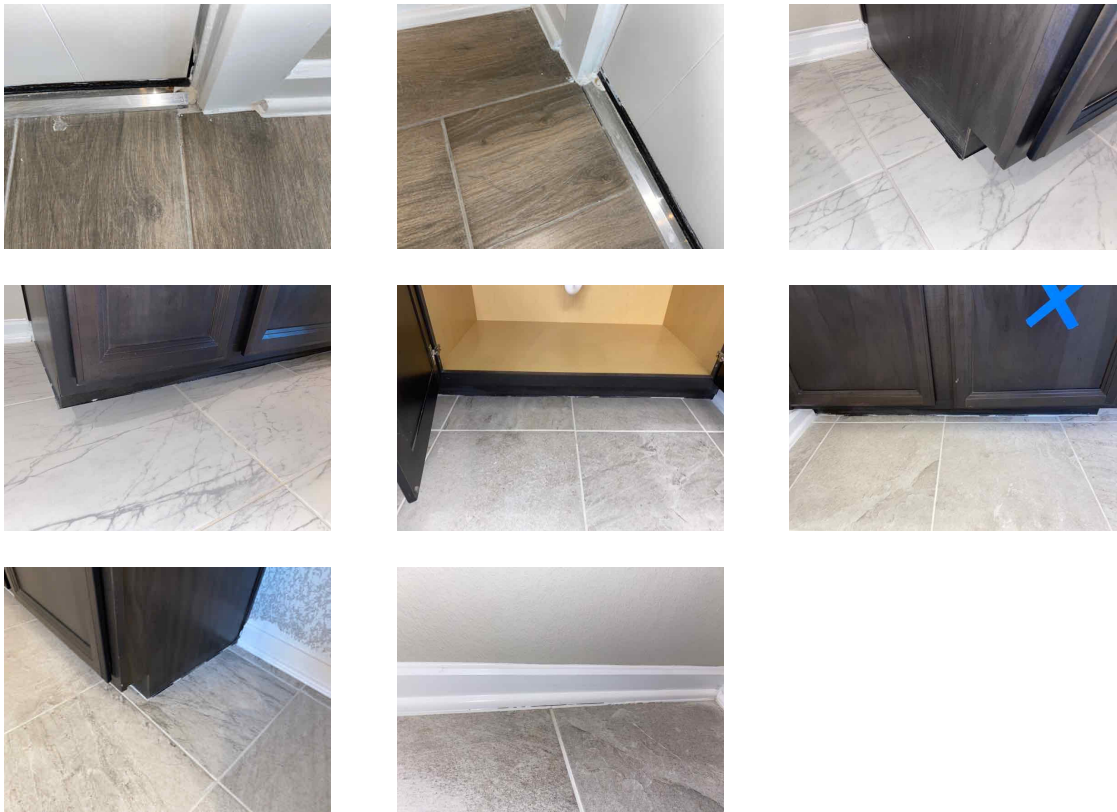
IMPR The flooring and floor trim pieces had limited gaps and irregularities that could be repaired.

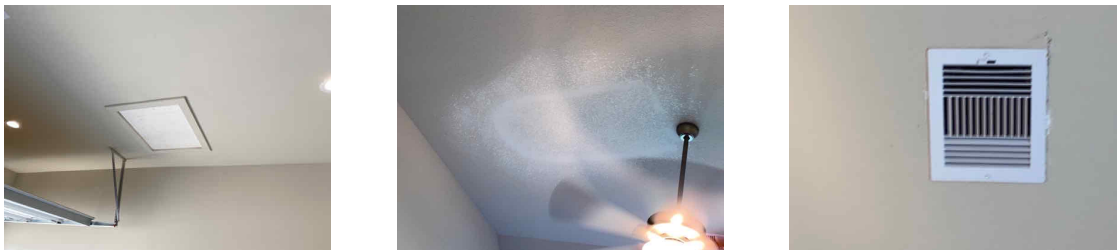
REP There were limited irregularities and marks at the ceilings that could be touched up and repaired.

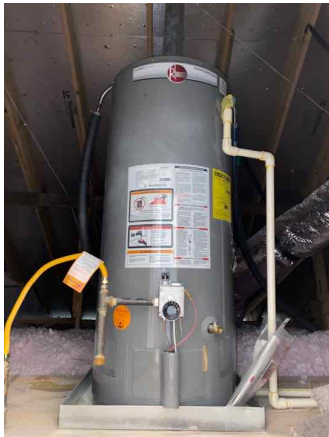
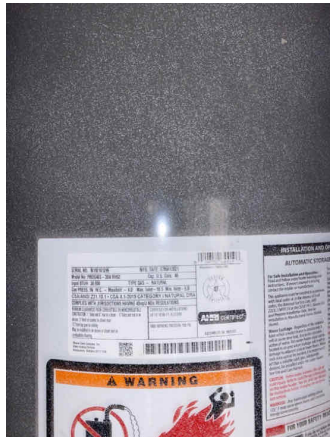
Views of the water heating equipment

40 gallon natural gas water heater,
made in 2021 by Rherm

The water heater heated water at the time of the inspection.
